**RESEARCH, DEVELOPMENT, DEMONSTRATION,  
EVALUATION, AND IMPLEMENTATION OF DEFENSE  
SAFETY OVERSIGHT COUNCIL (DSOC) WORKPLACE  
MISHAP REDUCTION INITIATIVES TO PROMOTE  
SUSTAINABILITY AND ENHANCE MISSION  
READINESS ACROSS THE DEPARTMENT OF  
DEFENSE**

**TASK No. 0438**

**Draft Technical Report:  
Tactical Rollover Alert Device for Tactical Vehicle Monitoring**

**February 20, 2007**

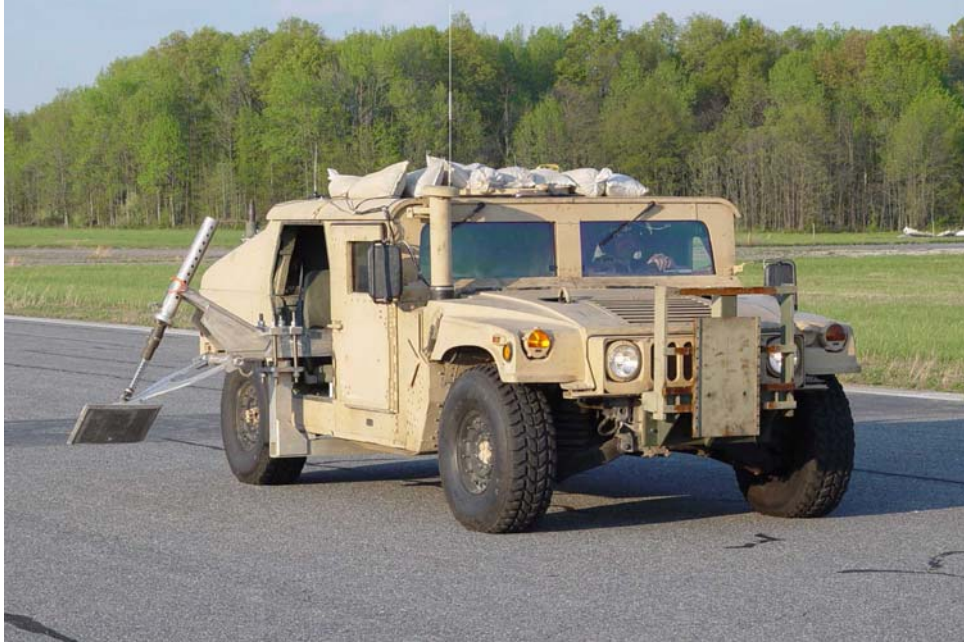
**Figure 1. M1114 HMMWV with Outriggers**

Tactical vehicle rollovers escalated dramatically after HMMWVs were up-armored. Though no formal study results are available yet, notional data indicates the causes of many of the rollovers could be from driving too fast for road conditions and/or due to distraction/failure to remain alert. Feedback from leadership in the field indicated that another factor affecting the increasing rollovers was that many incidental drivers were inexperienced and unfamiliar with the elevated center of gravity associated with the increased weight of the up-armored vehicles, a condition that made them more susceptible to rollovers. Figure 1 provides an image of a HMMWV.

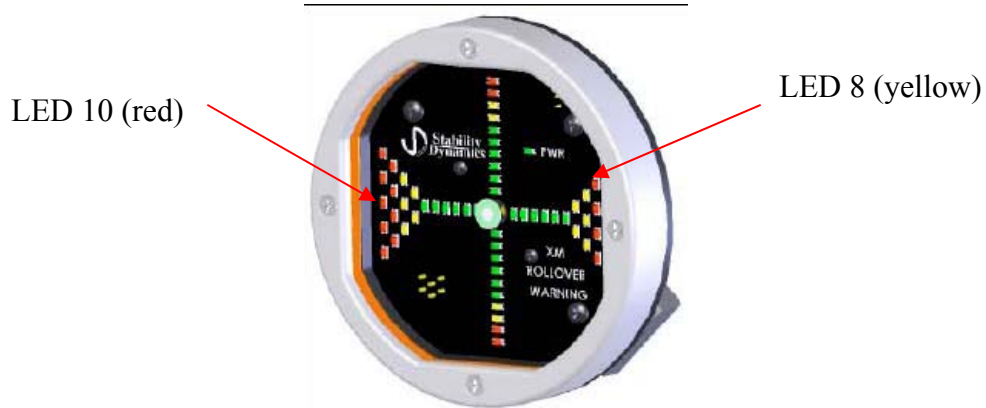
The driver’s display consists of ten Light Emitting Diodes (LEDs) for each lateral direction (left and right) and ten LEDs for each vertical direction (up and down). For each lateral and vertical direction, the six LEDs closest to the zero point (center of display) are green. The seventh and eighth LEDs are yellow, and the ninth and tenth LEDs are red. The eighth and tenth lateral LEDs are accompanied by audible warnings. A picture of the display is shown in Figure 3.

**Figure 3. Rollover Warning Device Driver's Display**

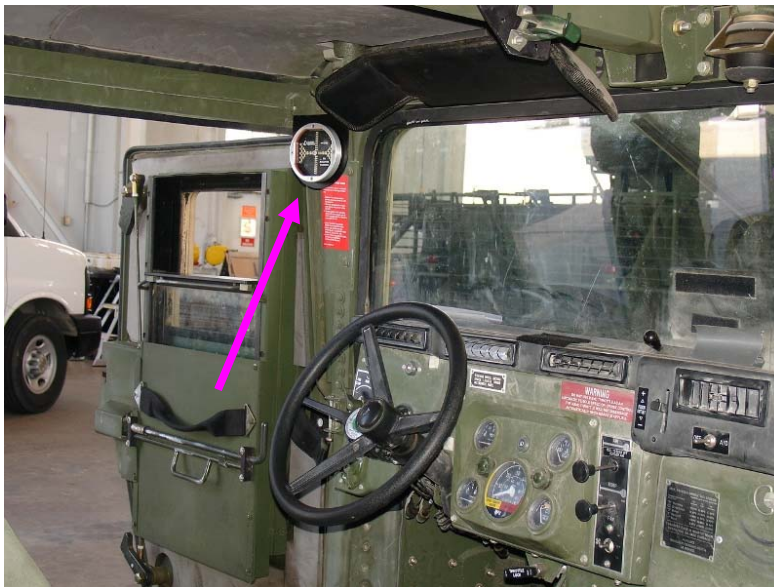
**Figure 4. Driver's Display Mounted in Top Left Corner of M1114 Cab**

The above picture of the display illustrates the display mounting point located in the top left corner of a M1114 HMMWV cab. This location was initially chosen by the test facility due to ease of installation. However, the indicator is located out of the normal driver field of view in this configuration requiring the driver to shift vision from the road to read the display. The Combat Readiness Center (CRC) recognized this hazard and had the indicator relocated toward the center. A Safety Confirmation Test will be required to determine the ideal location for the device.

The driver's display was noted as being somewhat distracting during dynamic testing due to the changing display lights, especially during movements like the double lane change steering and handling test. The placement of the driver's display requires minimal movement of the driver's eyes from the road to the display, but at the same time introduces a minor distraction during highly dynamic maneuvers.

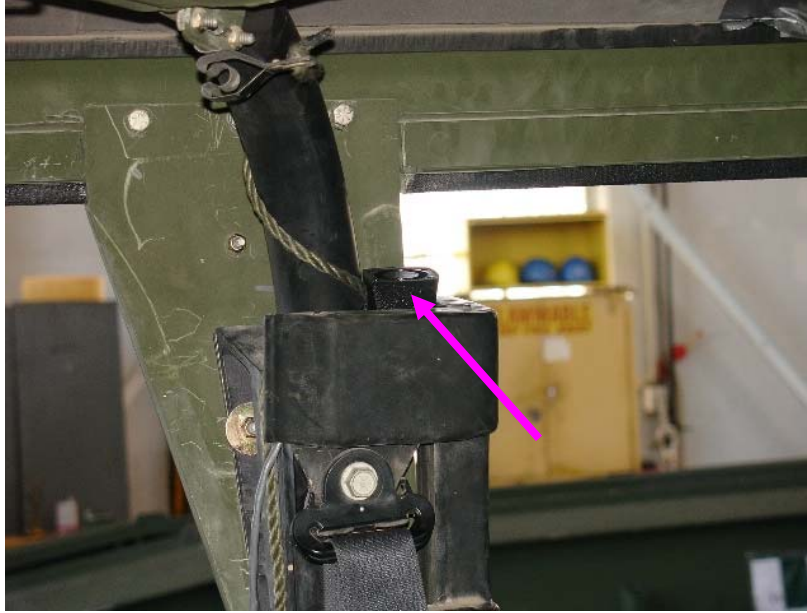
**Figure 5. Warning Siren Mounted Above the Driver's Seatbelt Shoulder Mount)**

The audible alarm, shown above in Figure 5, is the final component of the Warning Device. The alarm will emit a high volume and pitch squawk when the preset sensitivity setting is exceeded; in this case, LED 10. This alarm warns the driver that the lateral acceleration limit has been reached. A speaker built into the LG Alert Base Unit also emits a moderate beeping warning when the driver's display reaches its preset sensitivity setting; in this case LED 8 and LED 9.

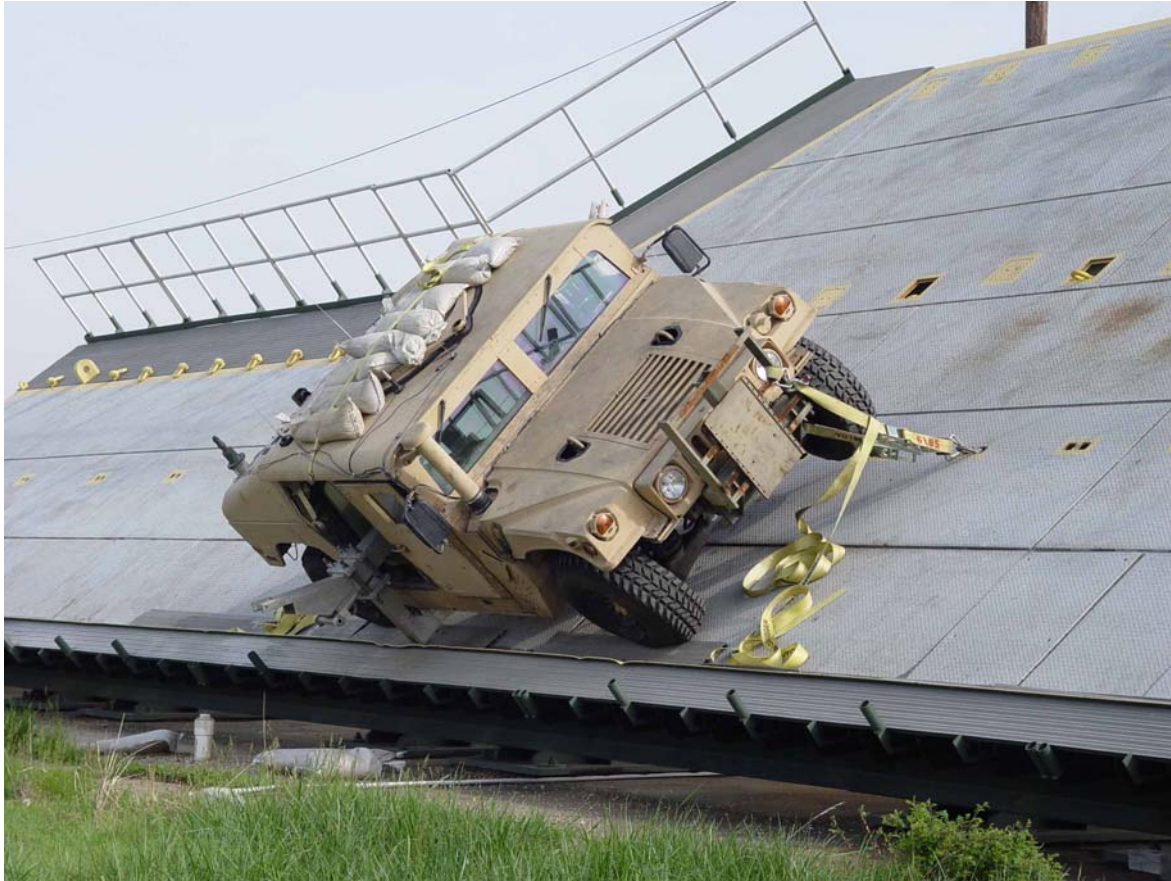
The static rollover threshold of the vehicle was measured using the ATC Tilt Table. The vehicle was positioned on the table and tilted about its roll axis until the rollover threshold was achieved. Restraining straps with enough slack allowed the vehicle to move freely but prevented the vehicle from rolling off the table. Maximum side slope angle and simulated lateral acceleration were determined with both the curbside (right) and roadside (left) of the vehicle positioned upslope. A photograph of the M1114 HMMWV on the tilt table is presented in Figure 6.

**Figure 6. M1114 HMMWV on the Tilt Table**

Static rollover results for the M1114 HMMWV at GVW are presented in Table 4. A comparison of the static rollover results with the LG Alert Box preset tilt angle thresholds for activation of LED 8 and LED 10 is presented in Table 5. The preset tilt angle thresholds for LED 8 and LED 10 were obtained from the LG Alert Box User/Installation Manual.
